Investigation report

***Ady Gil and
Shonan Maru No.2***

Collision on 6 January 2010

Maritime New Zealand

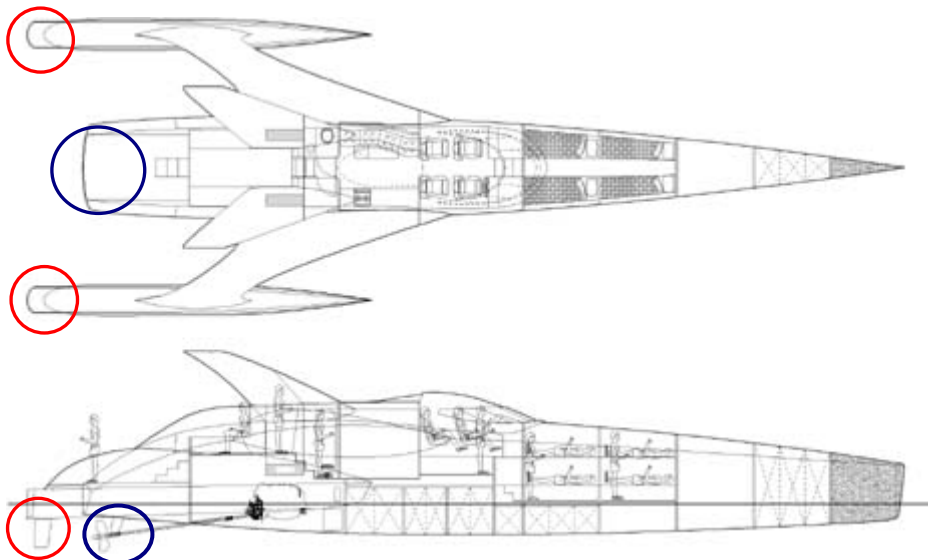
Figure 4 Diagram showing *Ady Gil*'s rudder and propeller positions
(Diagram courtesy of *Ady Gil*'s designer)

61. When moving *Ady Gil*'s throttles from neutral to ahead or neutral to astern, the respective gears had to be engaged, which was reported by the *Ady Gil* master to take between two and four seconds. Moving the throttles directly from ahead to astern without waiting for the gears to disengage and re-engage could potentially stall the engines.

62. A few days prior to the collision, the manual steering helm was found to have minor problems and the vessel was reportedly being steered under auto helm, which involves controlling the rudder with a dial control or buttons. This is a longer process than simply turning a wheel. This manner of steering is not as effective at low speeds or in conditions of moderate sea or swell.

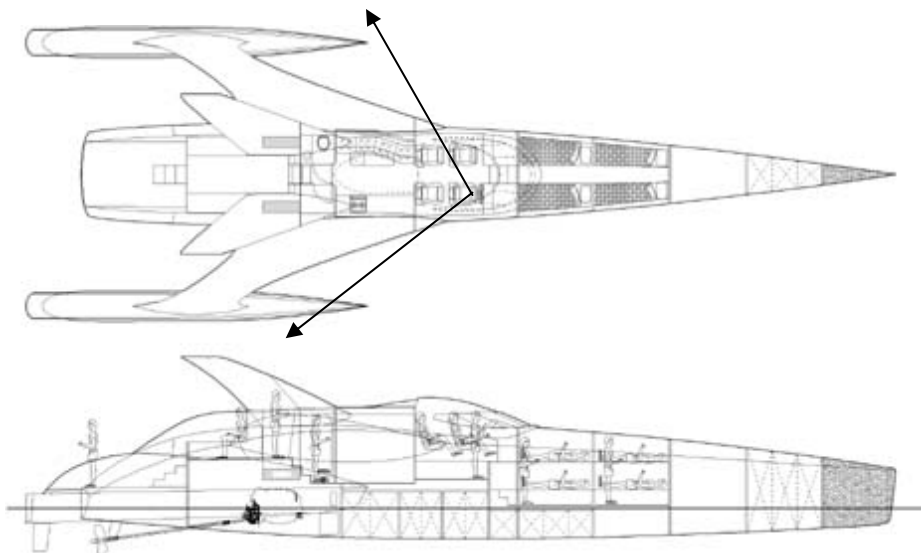
Figure 5 **Ady Gil**'s approximate area of visibility

63. **Ady Gil**'s forward windscreen was relatively small and designed to withstand the impact of waves. General visibility astern from the conning position was very limited, with only a small window providing any visibility directly astern. The master explained visibility from the helm as follows:

Visibility astern on the starboard side is, is limited in that you've kind of got to put your head over and you can look back I would say at about 45, maybe 50 degrees, maybe a little bit more, maybe 60 degrees astern on the starboard side you can look back, but from the driver's seat looking on the port side I would say you could look only 10 degrees astern of directly to port, if that makes sense, from your driver's seat. If you jump out of your seat, and you go over and you look back there.

64. Accordingly, the helmsman¹⁰ relied on verbal commands from a crewman standing at the stern when reversing or for maintaining a general lookout. Verbal commands would usually be done using handheld VHF radios, although radios were not used when engaging with the whaling fleet because of concerns they would be overheard. Alternatively, voice commands were relied on.

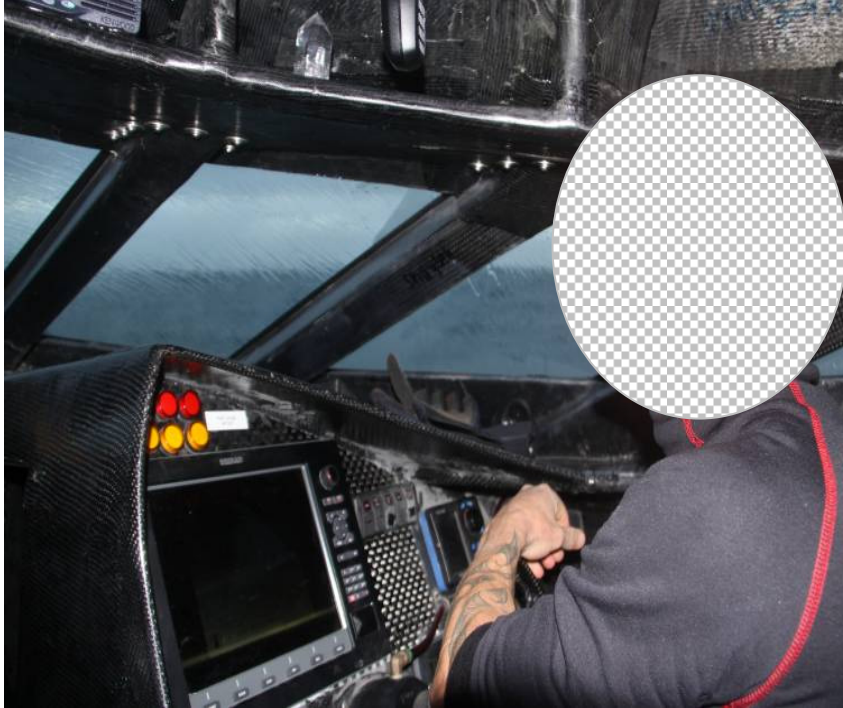
Figure 6 View forward and starboard from *Ady Gil*'s helm
(Photograph courtesy of SSCS)

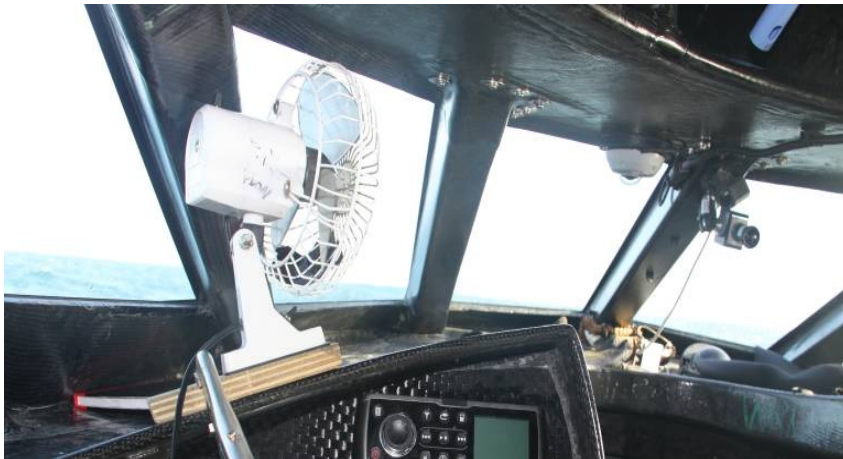
Figure 7 View forward from port side of *Ady Gil*
(Photograph courtesy of SSCS)

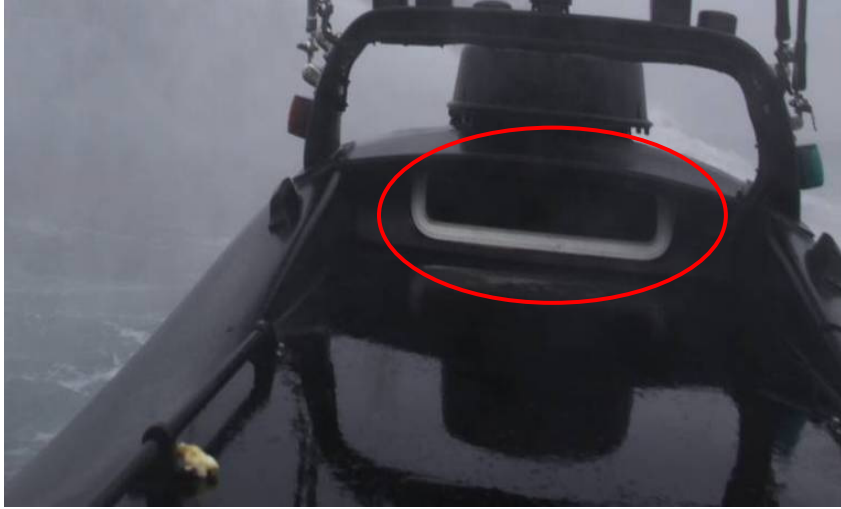
Figure 8 Small window at rear of **Ady Gil**'s cockpit
(Photograph courtesy of SSCS)

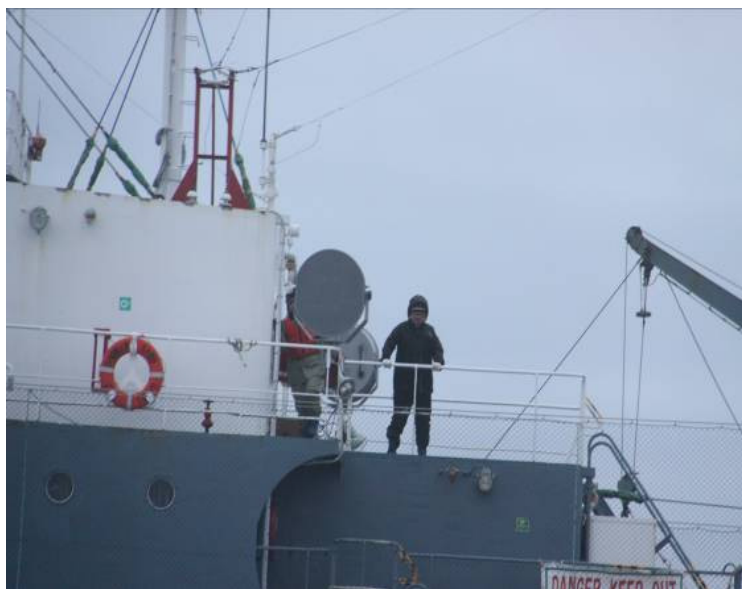
89. Following the warning, a long-range acoustic device (LRAD)¹⁵ sounded from **Shonan Maru No. 2** caught the attention of the master and crew at the stern of **Ady Gil**, but not the attention of the helmsman, who remained unaware of **Shonan Maru No. 2**'s approach.

Figure 10 **Shonan Maru No. 2**'s LRAD (the disc-shaped device at the centre of the photo)

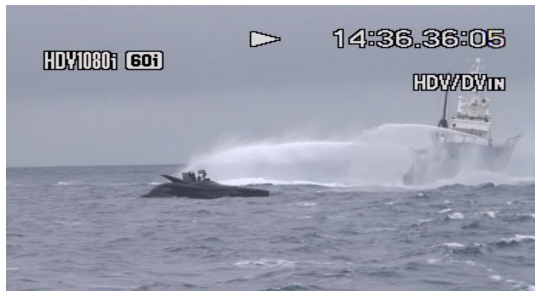
94. The following screenshots show the final seconds prior to the collision. Note that *Shonan Maru No. 2* appears to be yawing, which resulted in the vessel's heading continually changing.

Figure 11 *Shonan Maru No. 2* approaching *Ady Gil*
(Video courtesy of Lizard Productions)

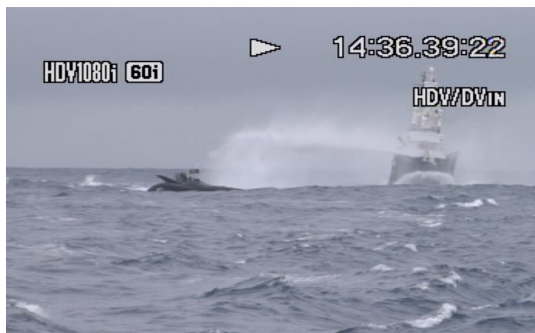
Figure 12 *Shonan Maru No. 2* initiating a turn towards *Ady Gil*
(Video courtesy of Lizard Productions)

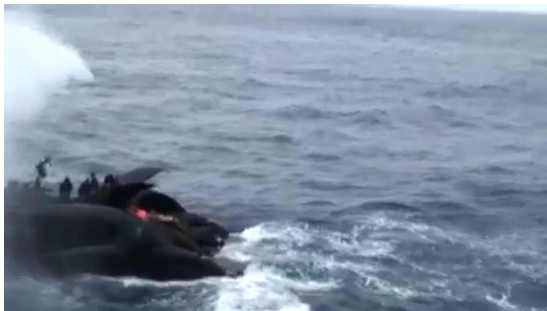
97. Crew from **Ady Gil** can be heard on the video soundtrack from their vessel, shouting “Whoa, whoa” just prior to the collision. When interviewed, the crew stated that this was not directed at anyone in particular and was a reaction to the imminent collision. It is apparent that around this time, **Ady Gil** had obtained some of the forward speed spoken of by the helmsman.
98. Screenshots from **Shonan Maru No. 2** video show the point at which the helmsman accelerated forward and then later reversed.¹⁶

Figure 16 Propeller wash indicating an increase of **Ady Gil**'s forward propulsion coinciding with the water monitors coming into range

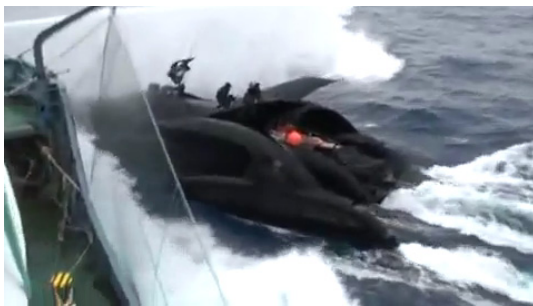
Figure 17 Propeller wash showing a further increase in **Ady Gil**'s propulsion

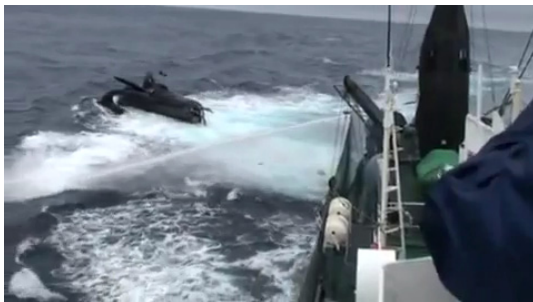
Figure 18 Propeller wash showing **Ady Gil**'s astern propulsion

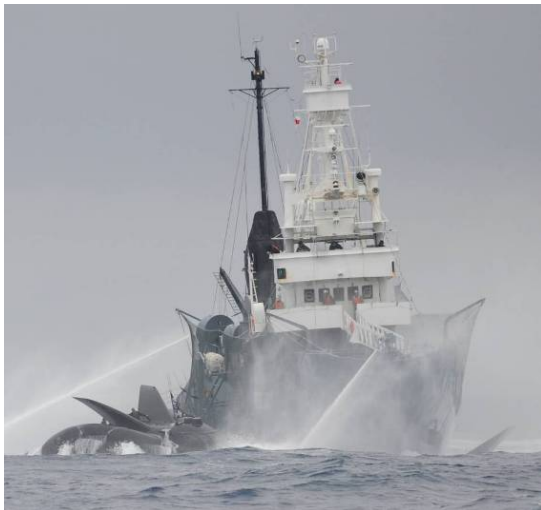
104. *Shonan Maru No. 2* and *Ady Gil* subsequently collided, striking *Ady Gil*'s bow and port sponson, taking approximately 3.5 metres off her bow. The moment of collision is shown in the photograph below. From the information available, it was not possible to plot accurately the final metres of each vessels track in relation to the other.

Figure 19 Collision
(Photograph courtesy of SSCS)

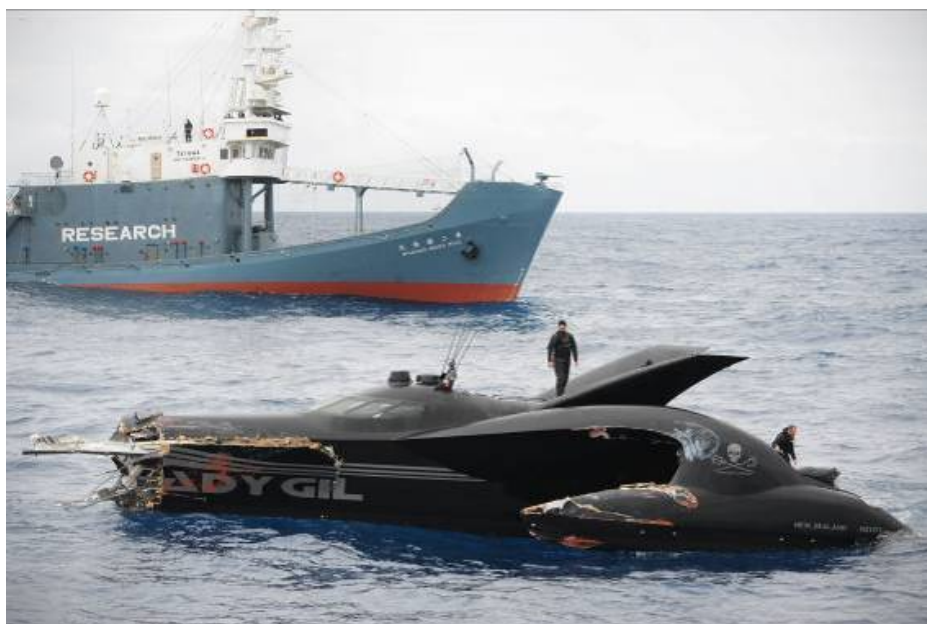
Figure 20 Damage to *Ady Gil*

126. Similarly, there was insufficient evidence to determine whether it was *Ady Gil*'s bow or sponson that was struck first. This could not be accurately determined without recovery of the vessel for examination. Attempts were made to retrieve the bow on to *Bob Barker*. However, it was logged with water, the weight of which caused it to break apart when lifted.

127. Inquiries were subsequently made with the manufacturer of *Ady Gil*. On assessing images of the damage sustained, the manufacturer expressed the opinion that the remainder of the hull, undamaged sponson and other watertight areas would be sufficient to keep the vessel afloat.

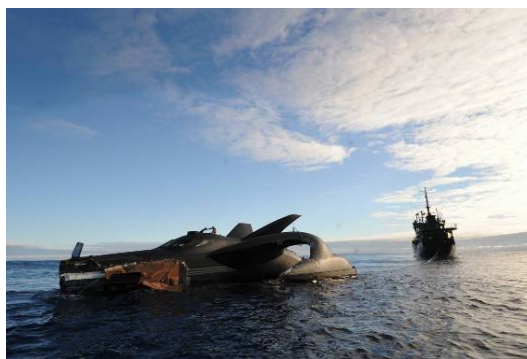
Figure 21 **Ady Gil** under tow

114. Around 0230–0300 hrs AEDT on 8 January 2010, **Ady Gil** was sitting low in the water and believed by crew on **Bob Barker** to be sinking. The master of **Ady Gil** was consulted and, with the view that the vessel was not likely to remain afloat, the decision was made to cut her free. **Ady Gil** was subsequently released from her tow and cast adrift to sink.
115. On 9 January 2010, the ICR faxed MNZ advising that it had located **Ady Gil** drifting at a position of 64° 27.7'S, 143° 03.4'E. The ICR also alleged that **Ady Gil** was leaking oil. This is believed to be residual oil leaking as a result of damage sustained in the collision.

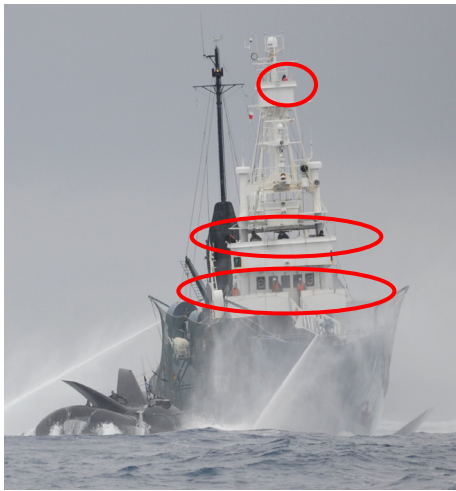
Figure 22 Eight crew maintaining a lookout on **Shonan Maru No. 2**
(Photograph courtesy of SCS)

153. There is no evidence to suggest that the lookout from **Shonan Maru No. 2** was ineffective. Therefore, the lookout maintained by **Shonan Maru No. 2** is not considered to be a factor in the collision.
